**AREA IN NEED OF
REDEVELOPMENT INVESTIGATION FOR
BLOCK 127, LOTS 29, 30, 31, 33, 39, 40, 43, & 44
TOWNSHIP OF BLOOMFIELD, NEW JERSEY**

Prepared for The Township of Bloomfield Planning Board by
PHILLIPS PREISS GRYGIEL LEHENY HUGHES LLC
Planning and Real Estate Consultants

July 2024

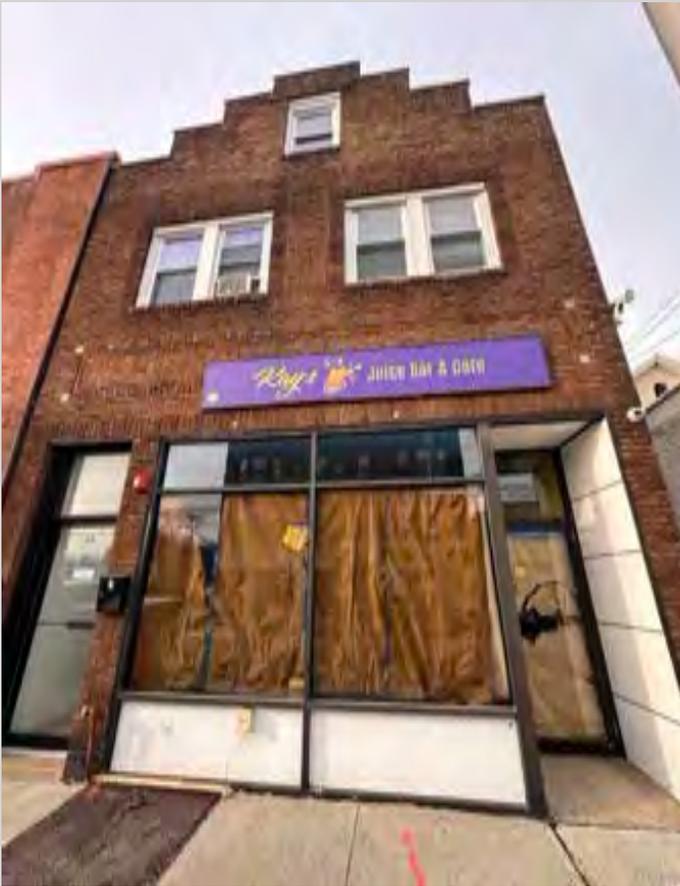
1

The exterior of the building exhibits a worn front façade (Photo 1), and the side and rear walls show a lack of maintenance, including wall damage, streaks and stains, and graffiti (Photos 2-6). The ground floor commercial unit windows are covered up with wrinkled and stained brown paper, which has a deadening effect on the pedestrian and retail environment. The front portion of the building displays exposed wiring and a rusted basement walk-in gate along the sidewalk (Photo 7). The rear facade also has an unfinished/damaged area of the wall, next to which lie various cluttered materials (Photos 8-9). Additionally, there is a siding leak in the space between the property and the adjacent property to the west that has been unrepairable as per the property owner, resulting in interior damage. (Photos 10-11). The shared narrow alley which provides access to the rear of the property contains cracks and unmaintained vegetation, as well as unscreened trash cans that are visible from the Dodd Street frontage (Photos 3 and 12). The ground floor residential unit can only be accessed from the side alley, which is an outdated and faulty arrangement/design.

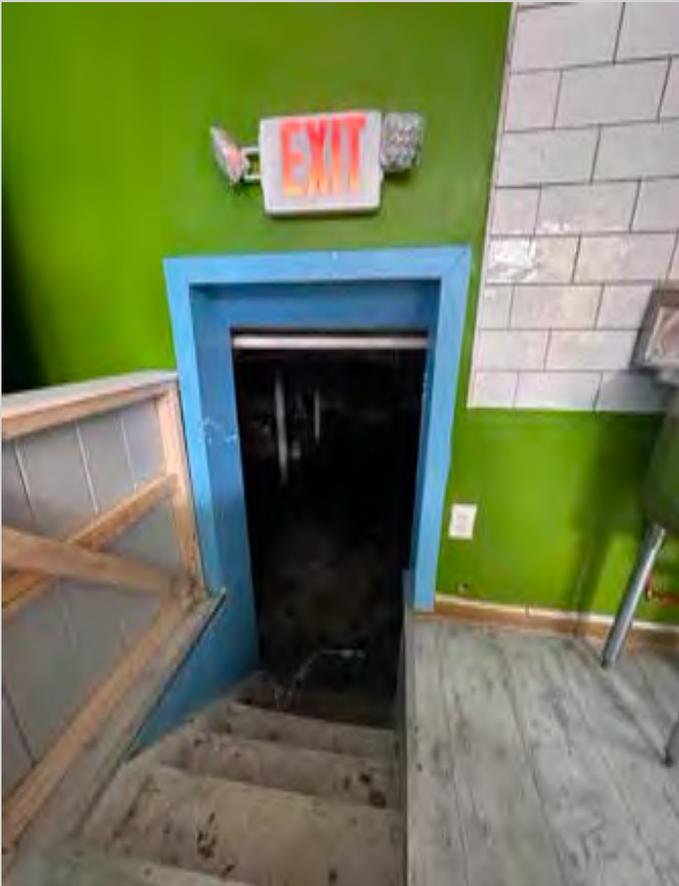
14

The interior of the building contains structural and layout issues for the commercial and residential units. The rear of the ground floor commercial unit has a set of narrow steps that leads to a partially finished back room with low ceilings (Photos 13-14), resulting in cramped conditions. The ceiling in this area is unfinished/damaged with exposed piping (Photo 15). Construction and painting materials

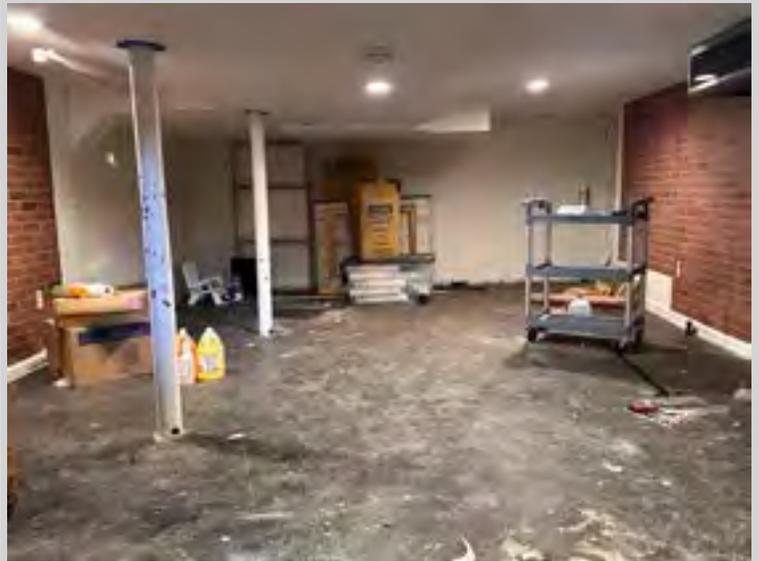
16

are scattered around the room, along with paint stains and debris (Photo 16). Regarding the residential units, the ground floor apartment is only accessible via an entrance in the shared alleyway along the side of the building, which is an outdated and faulty access arrangement. The top floor residential unit has stained walls and low ceilings, creating cramped and overcrowded conditions. The bedroom on the top floor only contains one narrow window, which results in an inadequate level of access to light. (Photo 17). The property also does not provide ADA handicap accessibility, showing the outdated nature and layout of the building.

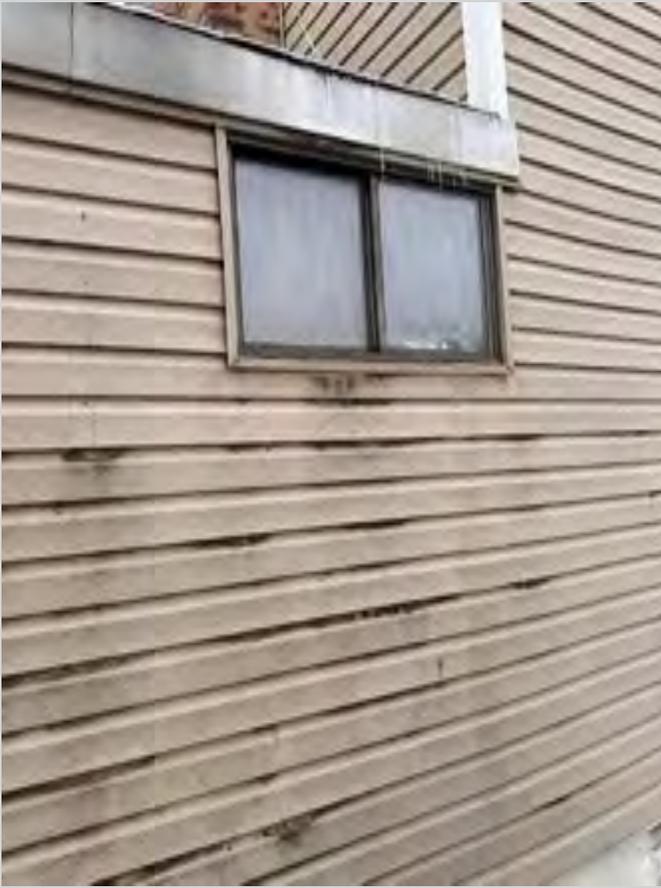
22

A site inspection of the property revealed several property maintenance issues, as the side brick facades show significant dirt accumulation and stains (Photos 18-21), along with exposed and

unscreened wiring (Photo 22). The shared narrow alley paths on both sides of the building contain various cracks and unmaintained vegetation (Photos 23 and 24). The door in the western side alley that provides access to the ground floor residential unit is tattered and in very poor condition, with several air conditioning units and other materials stored directly next to the entrance (Photos 25-26). The exterior staircase at the rear of the building is deteriorating and has an unstable handrail which is not properly mounted, creating a safety concern (Photos 27-29). The rear yard also contains unscreened dumpsters which are visible from both adjacent Lots 29 and 31 (Photo 30). In addition, the western-most storefront's entrance area exhibits cracks and chipped paint (Photo 31). The walkway within the second alleyway that runs adjacent to the property is also damaged and heavily cracked (Photo 32). Overall, the property is in declining structural condition as documented by the property owner, having consistent roof leaks, and requiring numerous repairs.

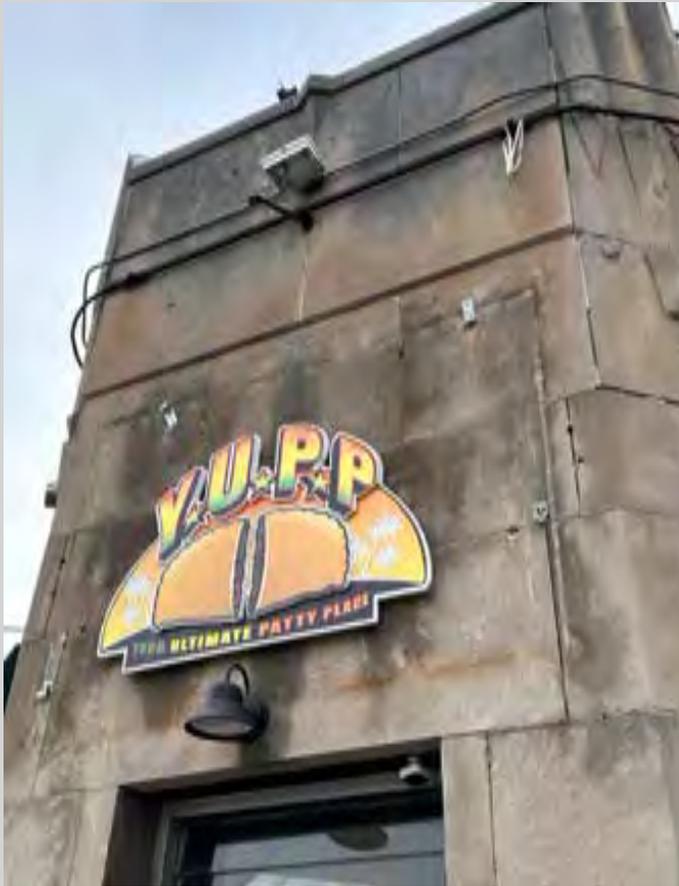
62

The rear entrance area in particular is thoroughly damaged, featuring an elevated entrance with concrete below that is cracked throughout (Photo 62). This represents an unsafe condition and is especially hazardous during the winter months. The rear of the building also contains several boarded-up windows, as well as those with rusted bars on them. Not only is this appearance uninviting, but it also results in a lack of ventilation and access to light for the internal commercial units (Photos 68-70). There are also various wires and mounted mechanical equipment along the rear building walls (Photos 71-72). The rear entrances additionally facilitate access to the basement through narrow staircases enclosed by a chain link fence. The steps are steep and pose a safety concern if not properly maintained, especially in case of snow/ice (Photo 73).

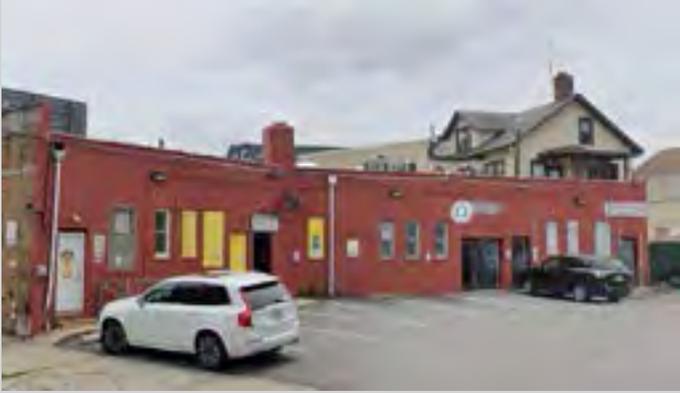
77

The parking lot layout represents a faulty arrangement/design. Multiple parking spaces are placed up against the building, fronting the commercial unit windows/entrances with no landscaping or separation from the building (Photo 77). The parking lot is also not screened/separated from the sidewalk or public realm along Myrtle Street. In fact, there is a parking space directly adjacent to the sidewalk with no physical separation, allowing for vehicles to drive over the sidewalk while exiting or entering the lot (Photo 78). This represents a safety hazard for pedestrians along the sidewalk. The property owner has additionally noted that the ingress/egress easement across this lot for the benefit of Lot 31 restricts the parking layout and configuration of spaces.

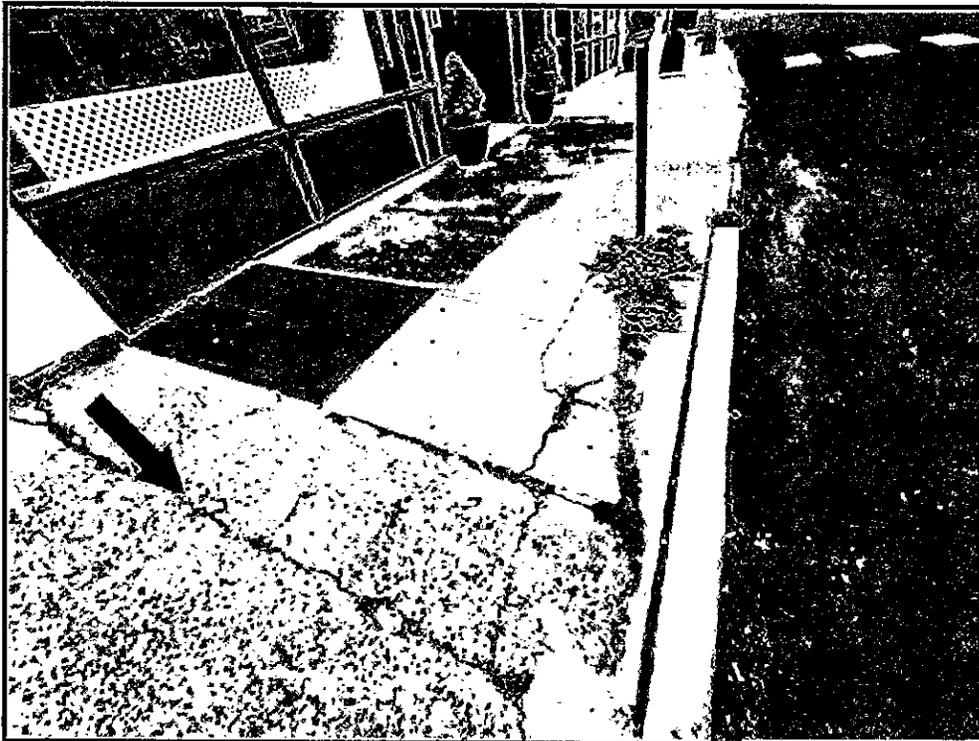
1. Exterior - Sidewalk Damage Trip / Fall Hazard

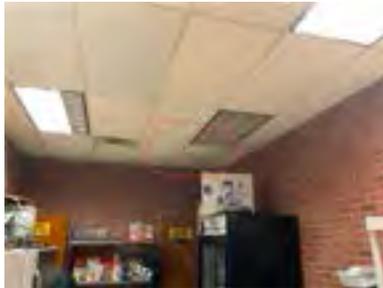
The roof is leaking in the restaurant area. Ceiling tiles are wet. A contractor should be contacted to provide an estimate for repairs and or replacement of the roofing system to limit the chance of future damage. Photos can also be taken to supplement the written documentation.

As proof of compliance, please provide photos of repaired area as well as invoice from work performed.

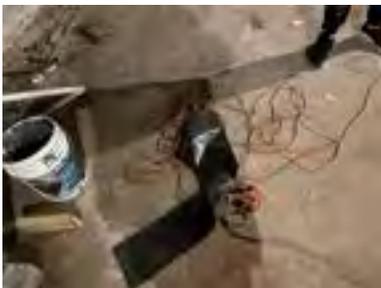
The wiring was exposed, and the cord was in very poor condition. Extension cords can serve as an ignition source and creates a fire hazard.

Additional electrical circuits and outlets should be installed to eliminate the use of extension cords. This cord should be taken out of service immediately.

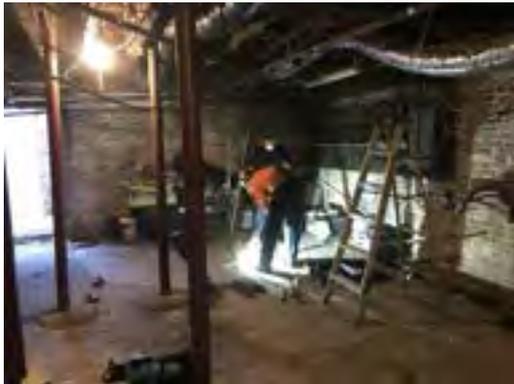
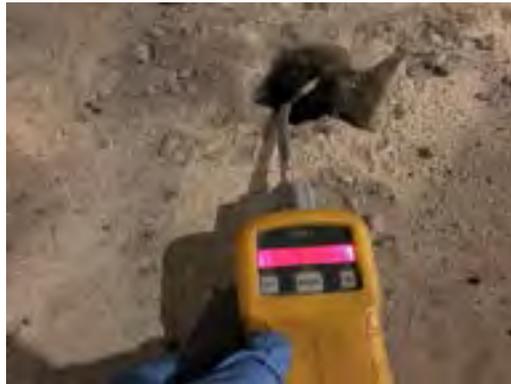
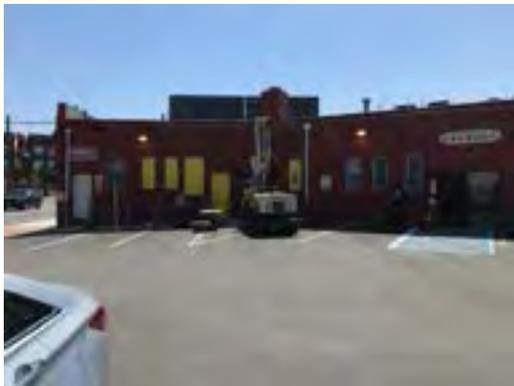
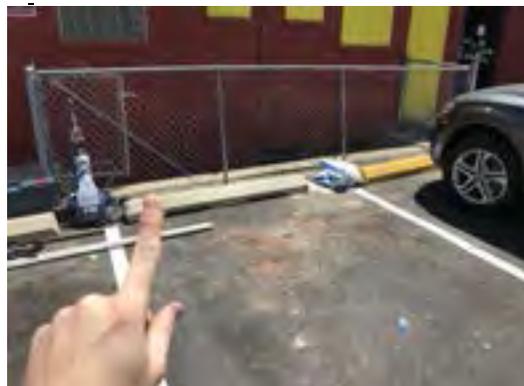
Photographs taken during the soil investigations are shown below:

Based on the results of the analyses, it can reasonably be ascertained that discharge from the past operations (i.e. dry cleaning) have impacted the subsurface soils throughout the building footprint area and portions of the rear parking lot. However, groundwater at the Site property could not be evaluated because there was no groundwater in any of the borings installed to bedrock and refusal at 10.5 feet below grade.

LEI recommends that a bedrock monitor well be installed to evaluate the groundwater impacts to the Site property from the former dry cleaner operations. In lieu of the groundwater data, LEI assumes that the Site groundwater is likely impacted with contaminants of concern associated with former dry cleaning operations. The extent of the groundwater contamination cannot be determined without a geology/hydrogeology including bedrock evaluation and groundwater concentration data.
