**STORMWATER MAINTENANCE MANUAL**

**PROPOSED MULTI-FAMILY RESIDENTIAL DEVELOPMENT  
78 LOCUST AVENUE**

BLOCK 129 – LOT 70

TOWNSHIP OF BLOOMFIELD  
ESSEX COUNTY, NEW JERSEY

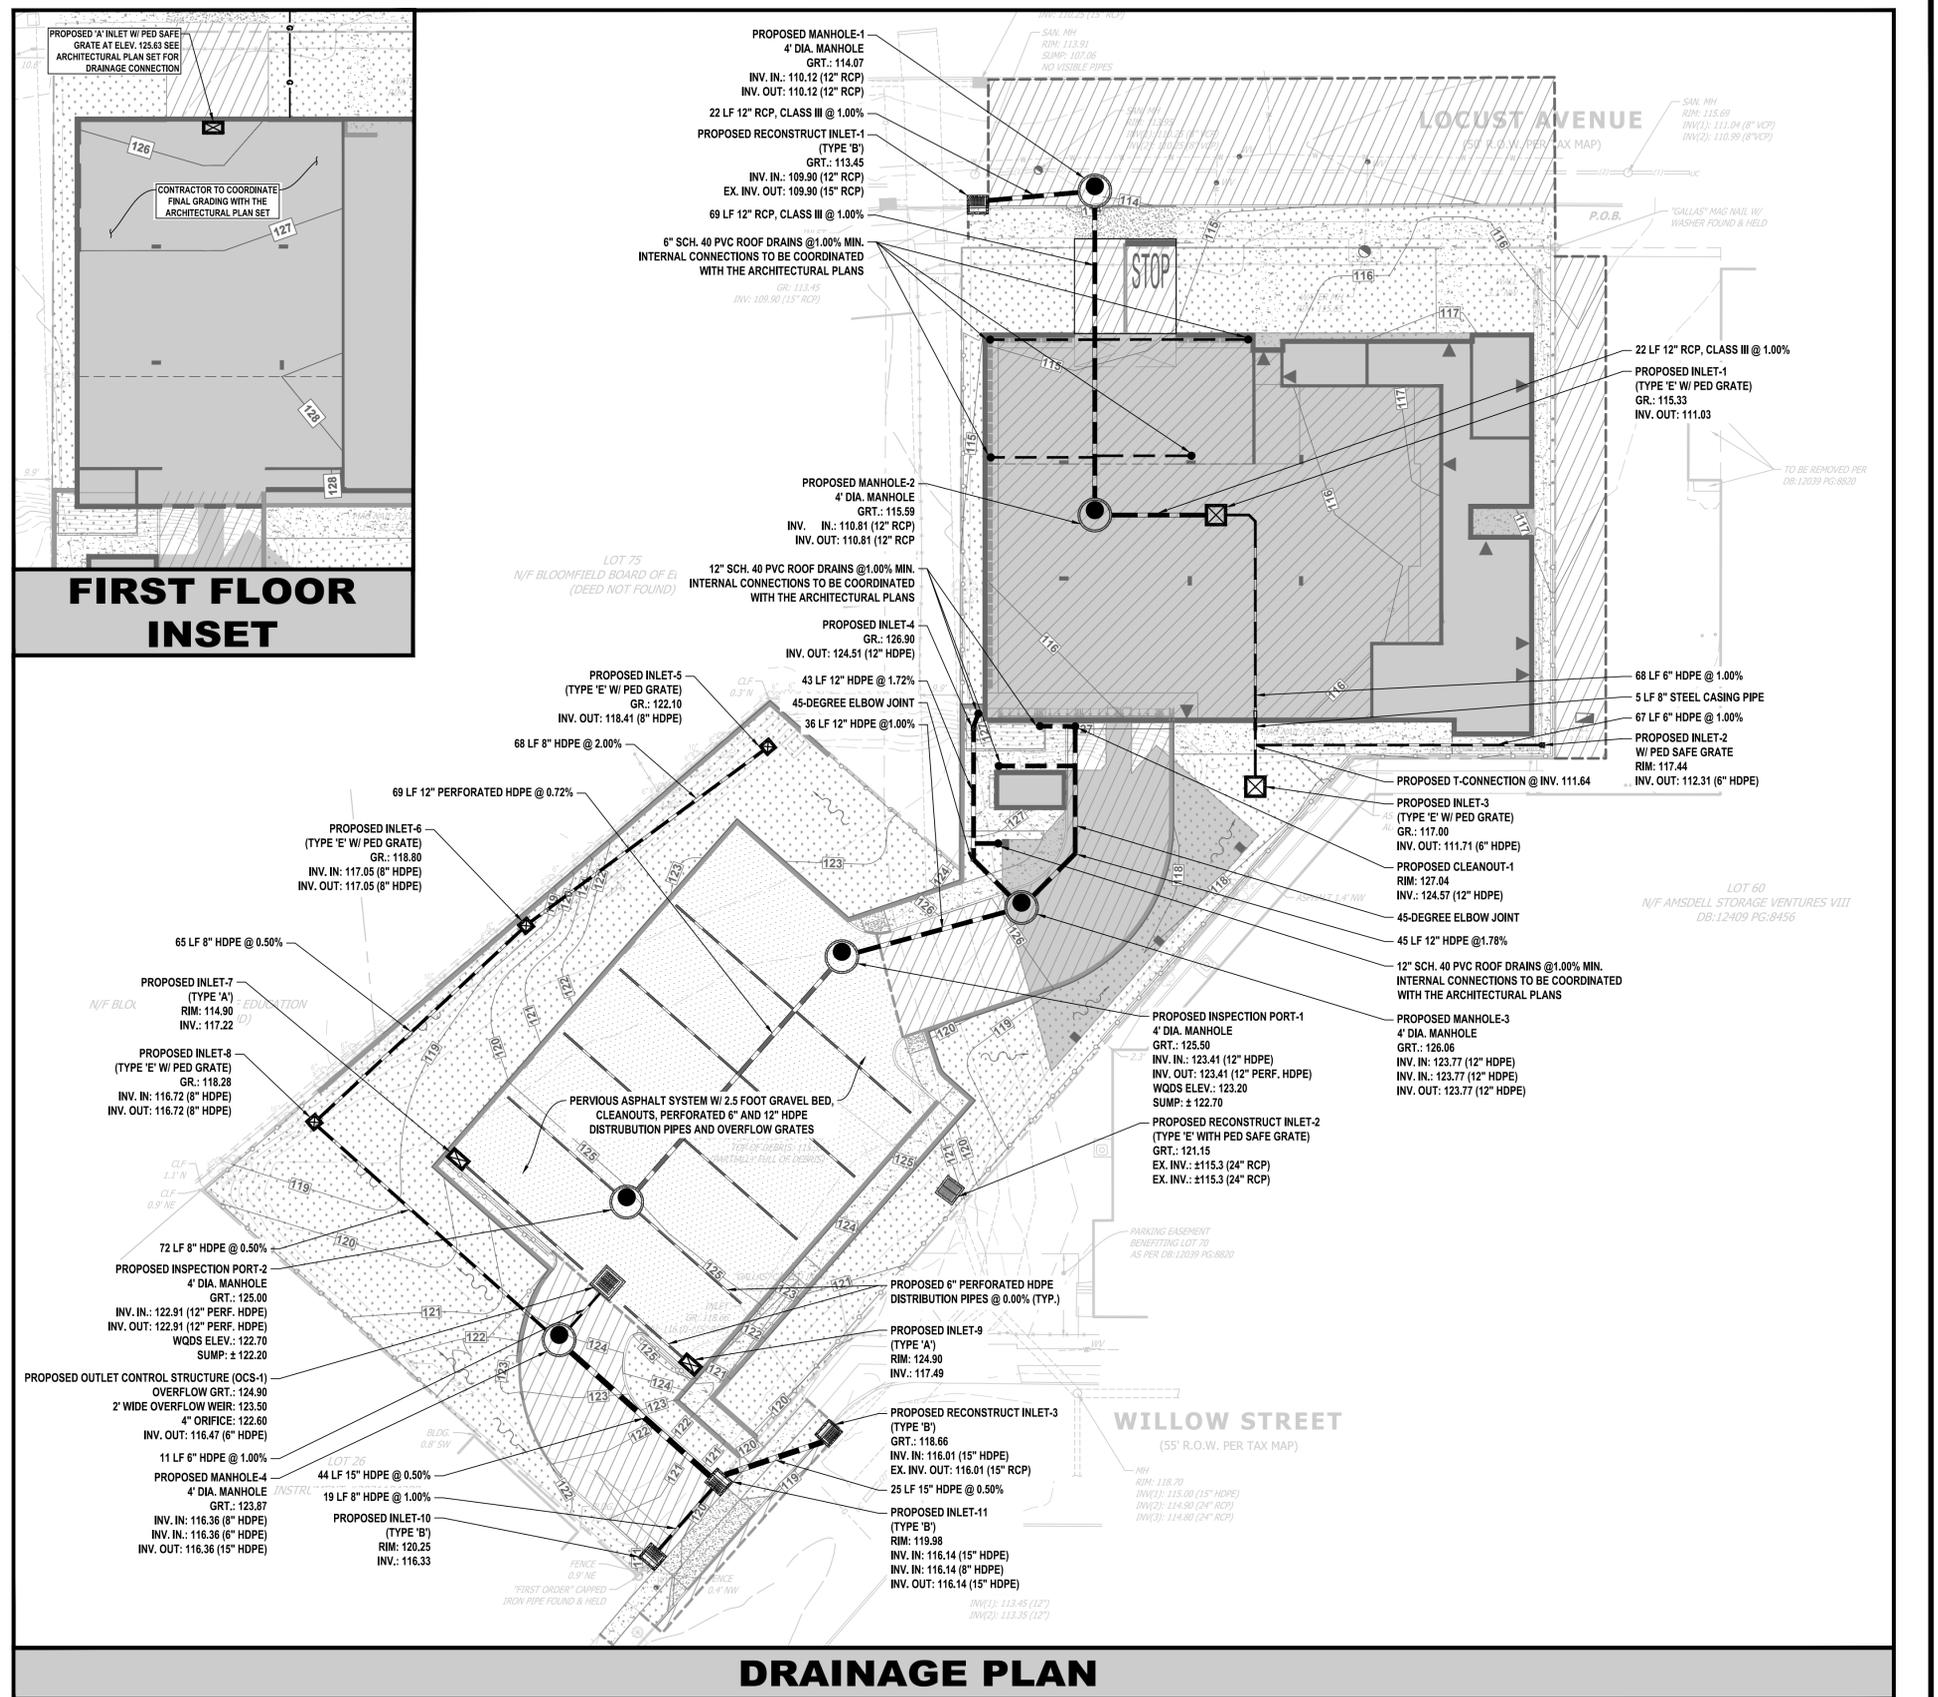
### DRAINAGE PLAN

**DRAINAGE AND UTILITY PLAN**  
**PROPOSED MULTI-FAMILY RESIDENTIAL DEVELOPMENT**  
**78 LOCUST AVENUE (BLOCK 129 - LOT 70)**  
**TOWNSHIP OF BLOOMFIELD**  
**ESSEX COUNTY**  
**NEW JERSEY**

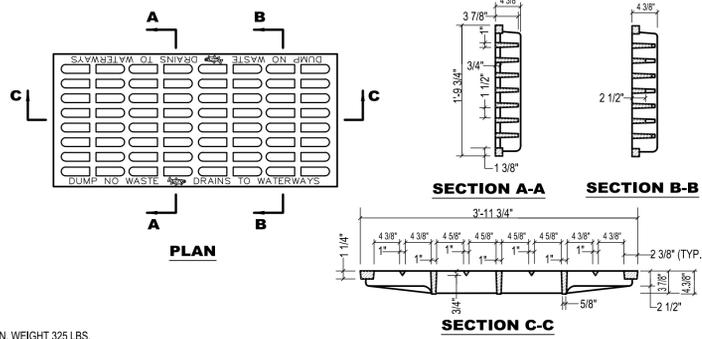
## BICYCLE SAFE GRATE (CAST IRON)

MIN. WEIGHT 325 LBS.  
NJDOT CD-602-1.8

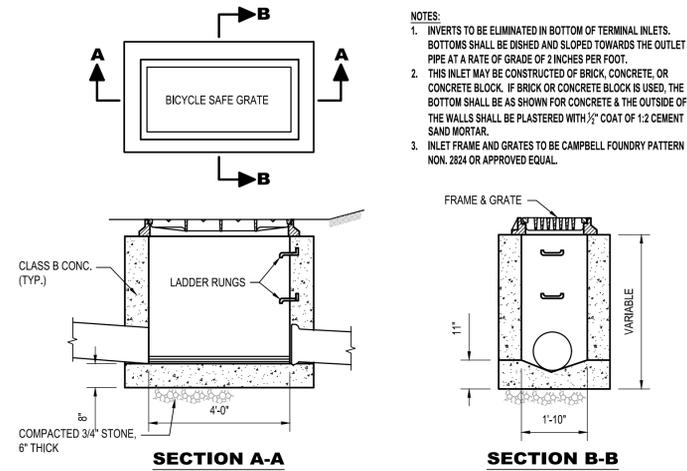
## INLET TYPE "A"

- NOTES:
- INVERTS TO BE ELIMINATED IN BOTTOM OF TERMINAL INLETS. BOTTOMS SHALL BE DISHED AND SLOPED TOWARDS THE OUTLET PIPE AT A RATE OF GRADE OF 2 INCHES PER FOOT.
  - THIS INLET MAY BE CONSTRUCTED OF BRICK, CONCRETE, OR CONCRETE BLOCK. IF BRICK OR CONCRETE BLOCK IS USED, THE BOTTOM SHALL BE AS SHOWN FOR CONCRETE & THE OUTSIDE OF THE WALLS SHALL BE PLASTERED WITH 1/2\"/>
  - INLET FRAME AND GRATES TO BE CAMPBELL FOUNDRY PATTERN NON. 2824 OR APPROVED EQUAL.

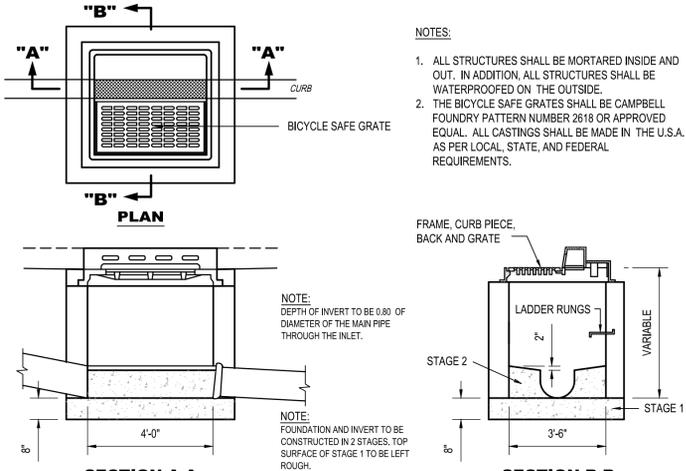
## INLET TYPE "B"

- NOTES:
- ALL STRUCTURES SHALL BE MORTARED INSIDE AND OUT. IN ADDITION, ALL STRUCTURES SHALL BE WATERPROOFED ON THE OUTSIDE.
  - THE BICYCLE SAFE GRATES SHALL BE CAMPBELL FOUNDRY PATTERN NUMBER 2616 OR APPROVED EQUAL. ALL CASTINGS SHALL BE MADE IN THE U.S.A. AS PER LOCAL, STATE, AND FEDERAL REQUIREMENTS.

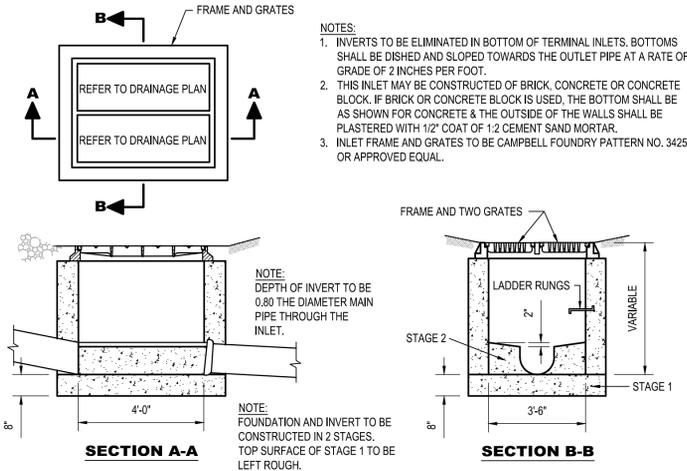
## INLET TYPE "E"

- NOTES:
- INVERTS TO BE ELIMINATED IN BOTTOM OF TERMINAL INLETS. BOTTOMS SHALL BE DISHED AND SLOPED TOWARDS THE OUTLET PIPE AT A RATE OF GRADE OF 2 INCHES PER FOOT.
  - THIS INLET MAY BE CONSTRUCTED OF BRICK, CONCRETE OR CONCRETE BLOCK. IF BRICK OR CONCRETE BLOCK IS USED, THE BOTTOM SHALL BE AS SHOWN FOR CONCRETE & THE OUTSIDE OF THE WALLS SHALL BE PLASTERED WITH 1/2\"/>
  - INLET FRAME AND GRATES TO BE CAMPBELL FOUNDRY PATTERN NO. 3425 OR APPROVED EQUAL.

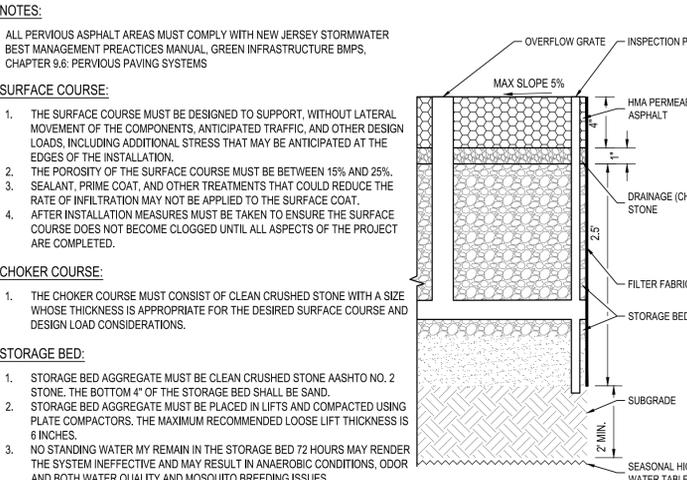
## POROUS PAVEMENT SYSTEM

ALL PERVIOUS ASPHALT AREAS MUST COMPLY WITH NEW JERSEY STORMWATER BEST MANAGEMENT PRACTICES MANUAL, GREEN INFRASTRUCTURE BMPs, CHAPTER 9.6: PERVIOUS PAVING SYSTEMS

- THE SURFACE COURSE MUST BE DESIGNED TO SUPPORT, WITHOUT LATERAL MOVEMENT OF THE COMPONENTS, ANTICIPATED TRAFFIC, AND OTHER DESIGN LOADS, INCLUDING ADDITIONAL STRESS THAT MAY BE ANTICIPATED AT THE EDGES OF THE INSTALLATION.
- THE POROSITY OF THE SURFACE COURSE MUST BE BETWEEN 15% AND 25%.
- SEALANT, PRIME COAT, AND OTHER TREATMENTS THAT COULD REDUCE THE RATE OF INFILTRATION MAY NOT BE APPLIED TO THE SURFACE COAT.
- AFTER INSTALLATION MEASURES MUST BE TAKEN TO ENSURE THE SURFACE COURSE DOES NOT BECOME CLOGGED UNTIL ALL ASPECTS OF THE PROJECT ARE COMPLETED.

- STORAGE BED AGGREGATE MUST BE CLEAN CRUSHED STONE AASHTO NO. 2 STONE. THE BOTTOM 4\"/>
- STORAGE BED AGGREGATE MUST BE PLACED IN LIFTS AND COMPACTED USING PLATE COMPACTORS. THE MAXIMUM RECOMMENDED LOOSE LIFT THICKNESS IS 6 INCHES.
- NO STANDING WATER MAY REMAIN IN THE STORAGE BED 72 HOURS MAY RENDER THE SYSTEM INEFFECTIVE AND MAY RESULT IN ANAEROBIC CONDITIONS, ODOR AND BOTH WATER QUALITY AND MOSQUITO BREEDING ISSUES.

The pervious paving system consists of the pavement section, distribution pipes, inspection ports, outlet control structures, stone bed and appurtenances. The surface course must be inspected after every storm exceeding 1 inch of rainfall. If mud or sediment is tracked onto the surface course, it must be removed as soon as possible. Removal should take place when all runoff has drained from the surface course. The surface course must be inspected, at least once annually, for cracking, subsidence, spalling, erosion, deterioration and unwanted vegetation. Remedial measures must be taken as soon as possible. Herbicides must not be applied. The surface course of a pervious paving system must be vacuum swept, not power swept, at least four times per year. Vacuum sweeping must be followed by either air blowing, or high-pressure power washing
